Manhole Inspection Summary

Manhole # S23A__014MH

Insp Date: **7/25/07 2:05 PM**

Location Address: **716 MOUNT-GIMORE**

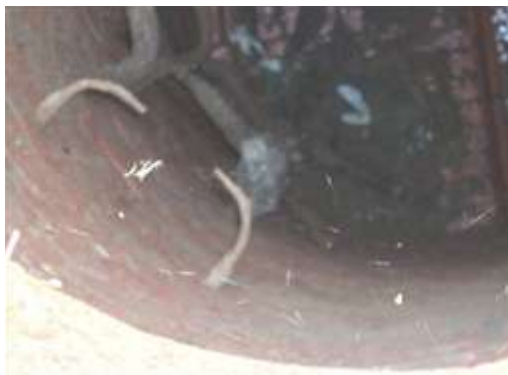
Defect 3

Surcharge ☒ **Evidence Of Surcharge** Depth: **3** (ft.) ☐ Active Surcharge Present

SURCHARGE EVIDENCE ON THE STEPS

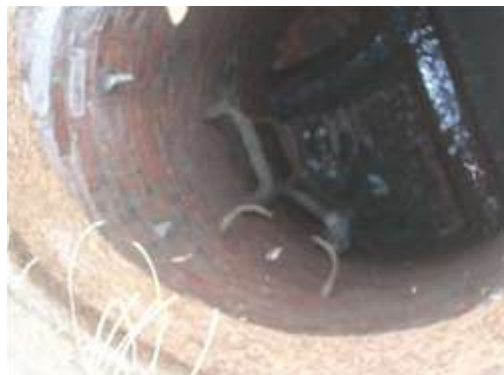
Defect 2

Steps Count: **4** Missing: **2** ☒ **Corroded**

CORRODED AND MISSING STEPS

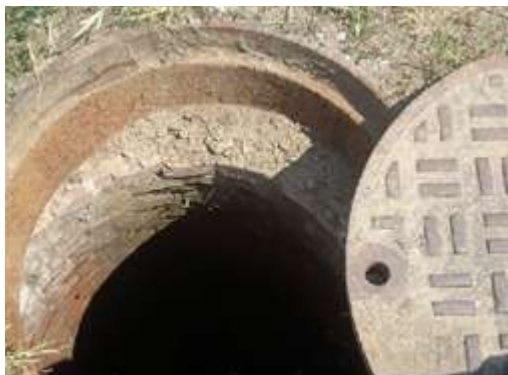
Defect 1

Frame Offset: **5** (in.) Condition: ☒ Sound ☐ Cracked ☐ Leaks

FRAME OFFSET
